Water Compliance Inspection Report

**NPDES
Inspection Report**

**Veldhuis Dairy, LLC
(NPDES Permit #: Unpermitted)**

Inspection Date: April 27, 2017

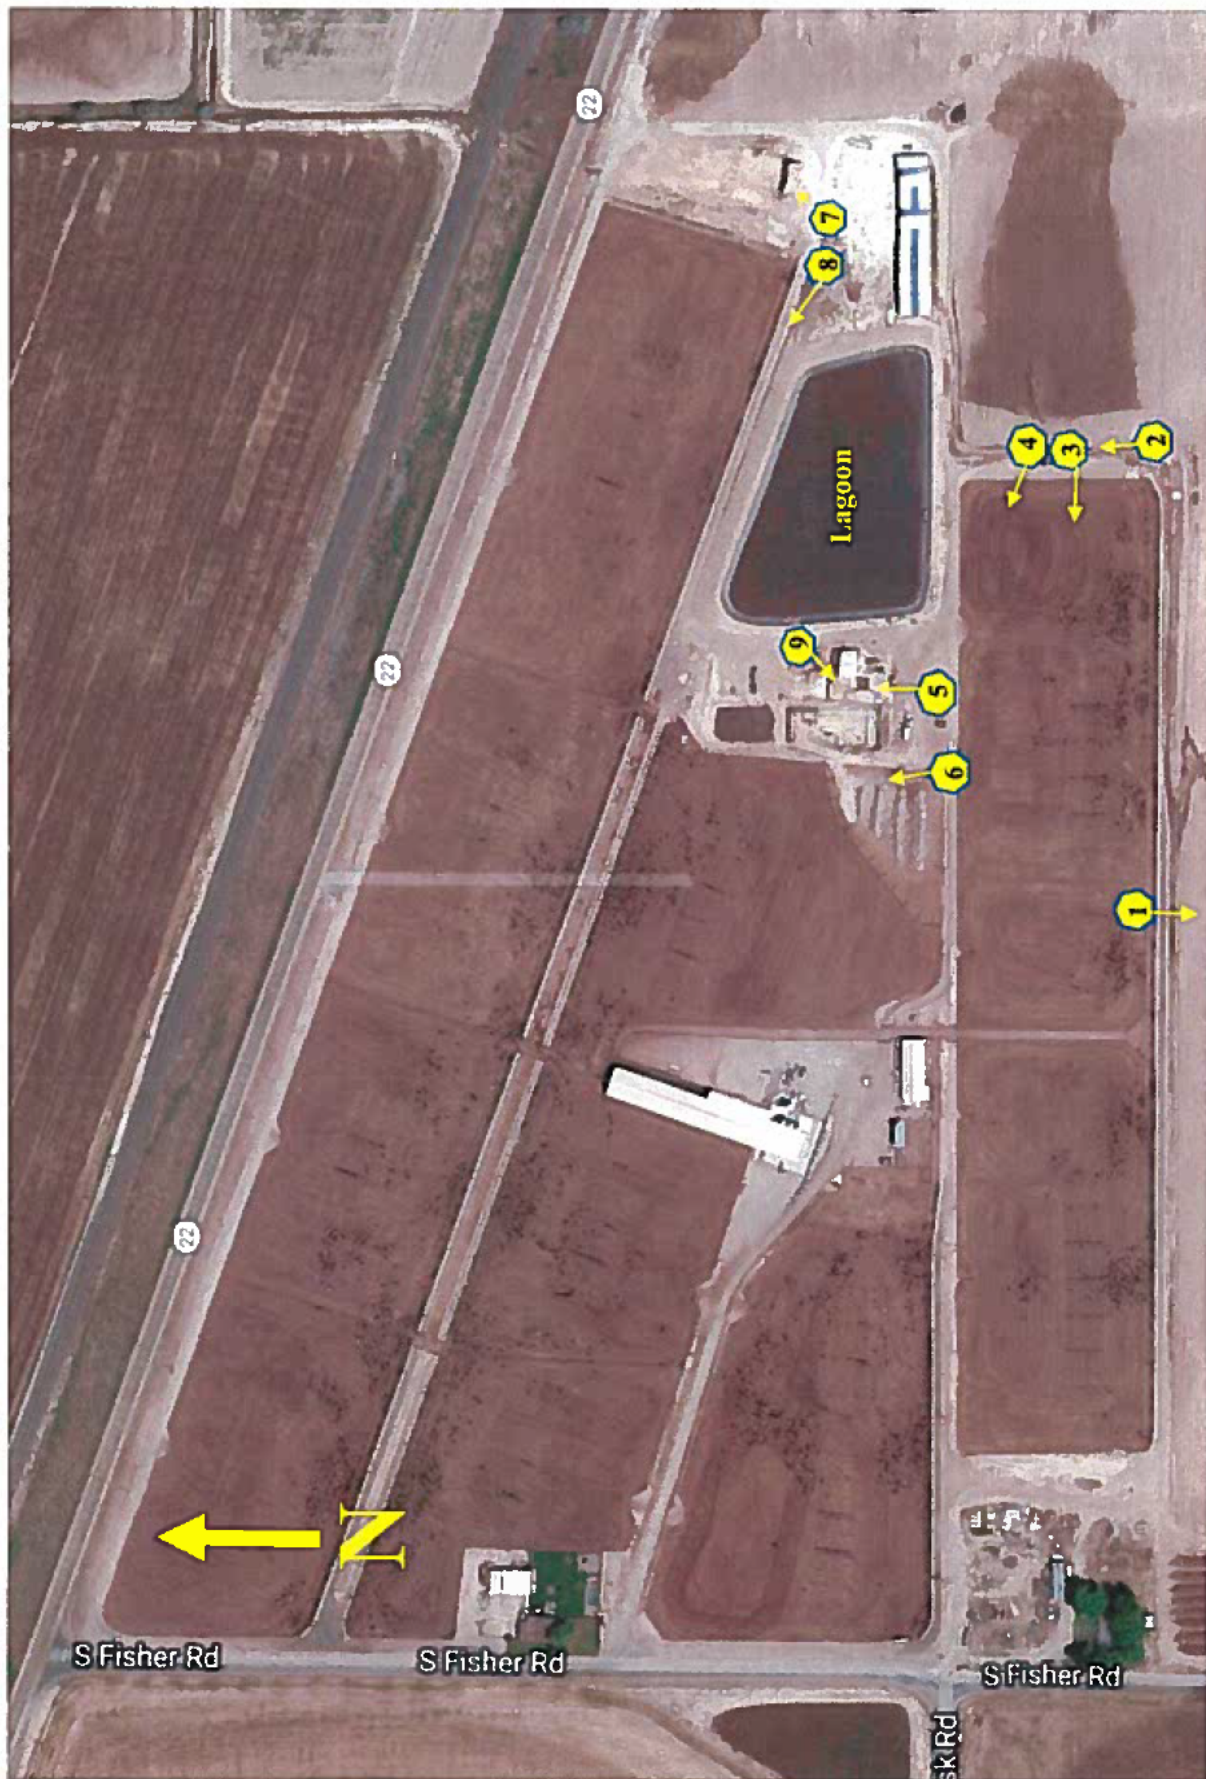
Veldhuis Dairy, LLC

This Attachment includes an aerial image of the facility. This aerial image contains hexagons (⬡→) which identify the approximate location of the photographer where certain Photograph Documentation photographs were taken. The number within the hexagon corresponds with the Photograph Documentation photo number. The arrow attached to the hexagon indicates the direction of the photograph.

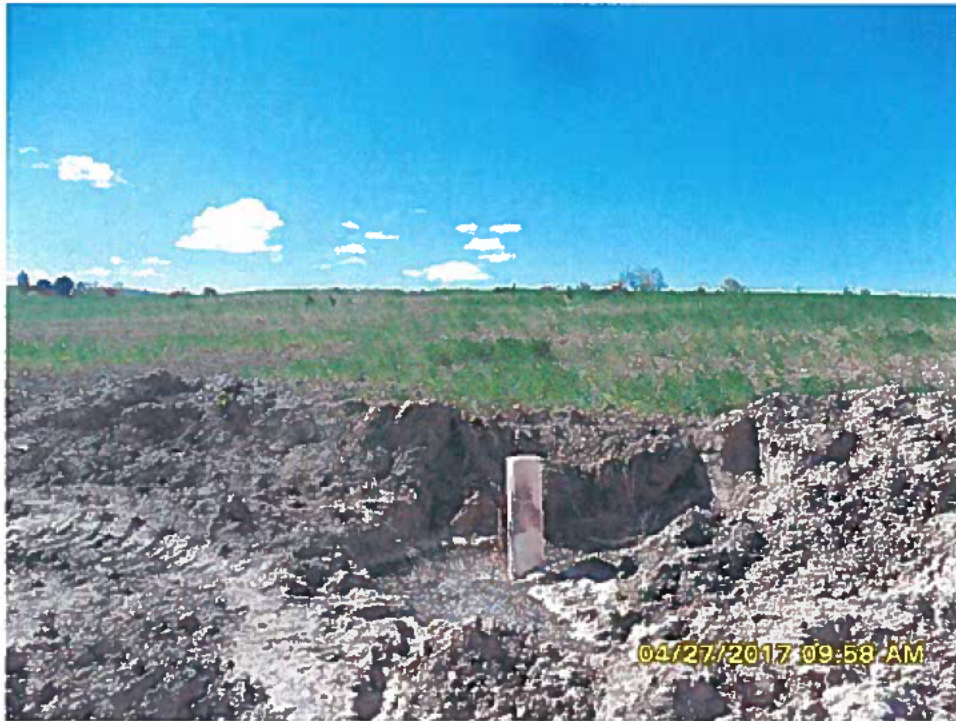
Photo #1: Southerly view of the area just south of the south boundary of the confinement areas. This is a view in the vicinity of a piped (possible) waters of the United States. This piped waterway is routed under the confinement areas. Camera photograph #SAM 2780.

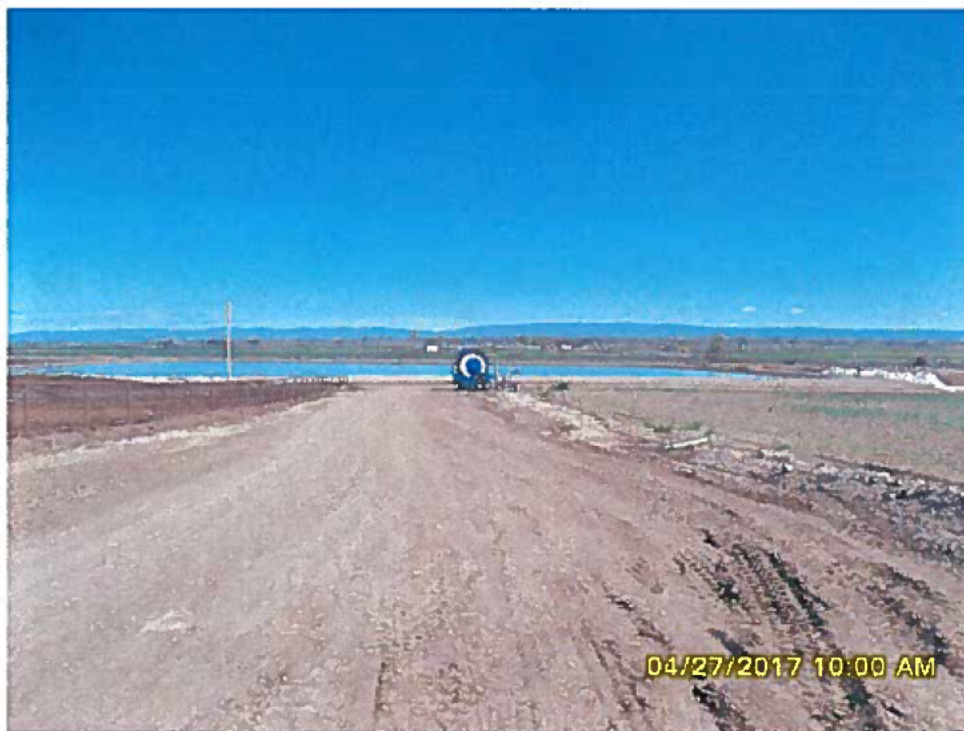
Photo #2: Northerly view showing the manure lagoon. Camera photograph #SAM 2781.

As indicated above, the facility stores wastewater in two wastewater storage lagoons. One lagoon is located onsite. The onsite lagoon is lined with a 40 mil. synthetic liner and was built in 2012. This onsite lagoon has a capacity of 5.5 to 6 million gallons.

- sedimentation basins (see photograph #6 of Attachment A),
- wastewater storage lagoon (see photograph #2 of Attachment A), and
- the compost piles (see photograph #10 of Attachment A).

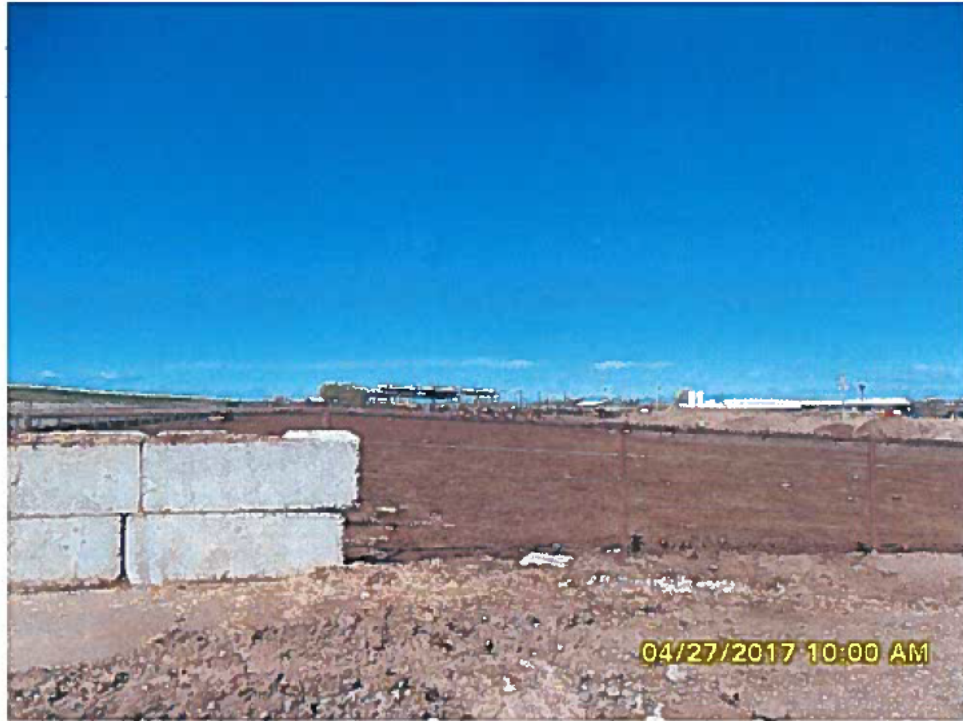
Photo #3: Westerly view showing the open lot animal confinement areas along the south side of the facility. Camera photograph #SAM 2782.

- animal confinement areas (see photograph #s 3, 4, and 8 of Attachment A),
- solids separator (see photograph #s 5 and 9 of Attachment A),

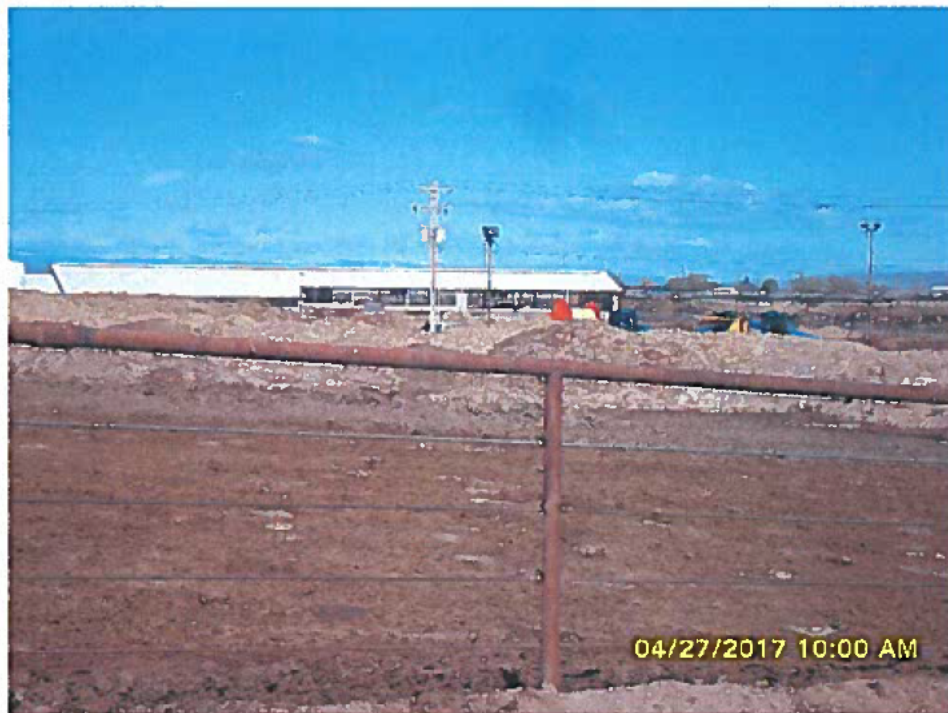
Photo #4: Northwesterly view showing a closeup view of the open lot animal confinement area near the southeast corner of the facility. Camera photograph #SAM 2783.

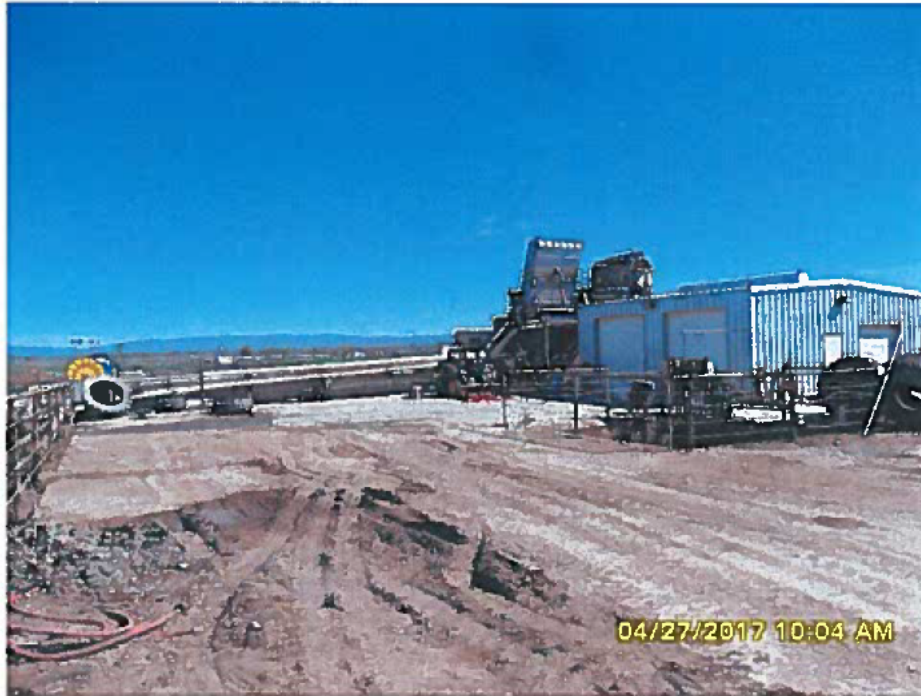
Photo #5: Northerly view showing the solids separator. Camera photograph #SAM 2784.

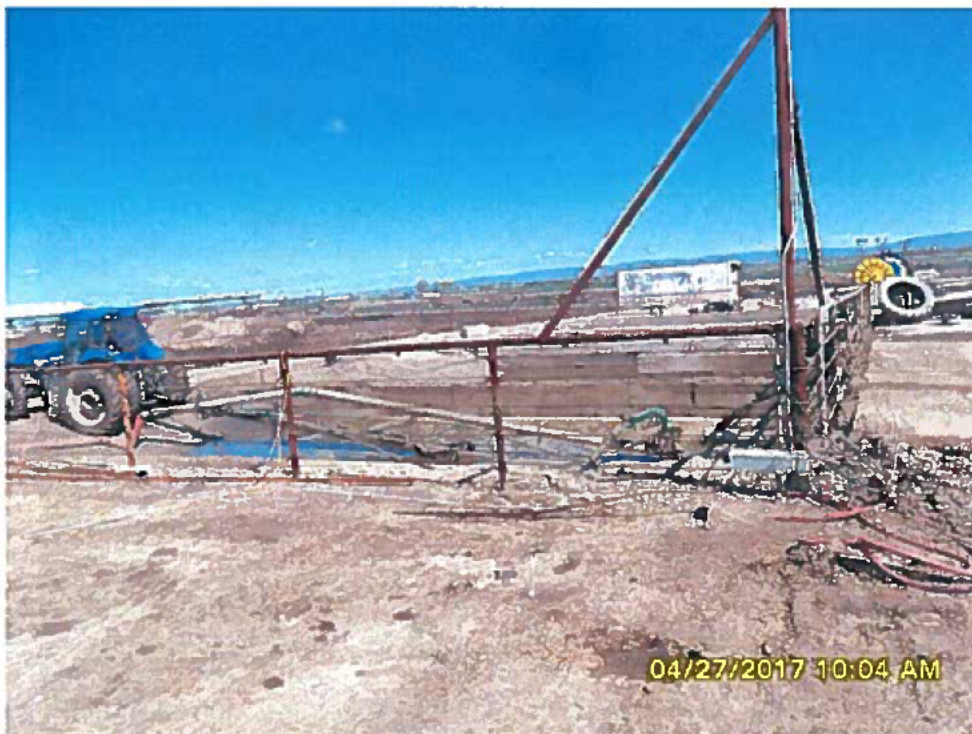
Photo #6: Northerly view showing sedimentation basins used to further settle out solids. The separated liquids from these basins are routed to the lagoon for storage until it is land applied. Camera photograph #SAM2785.

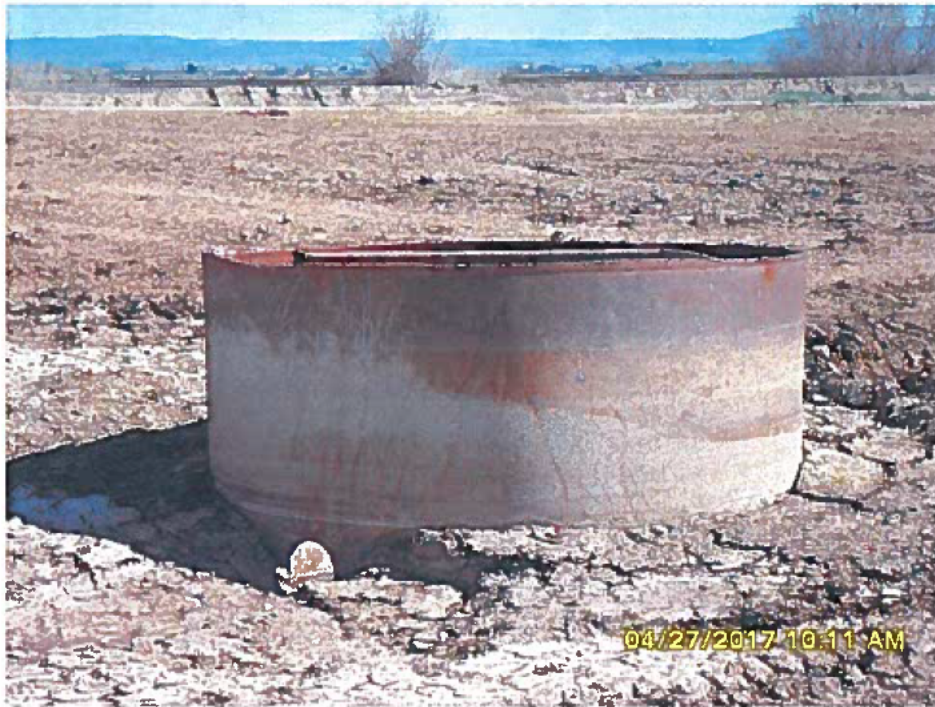
Photo #7: View of one of two catch basins at the facility. These catch basins are located in low spots around the confinement areas. Water captured in these basins are then routed to the lagoon. Camera photograph #SAM 2786.

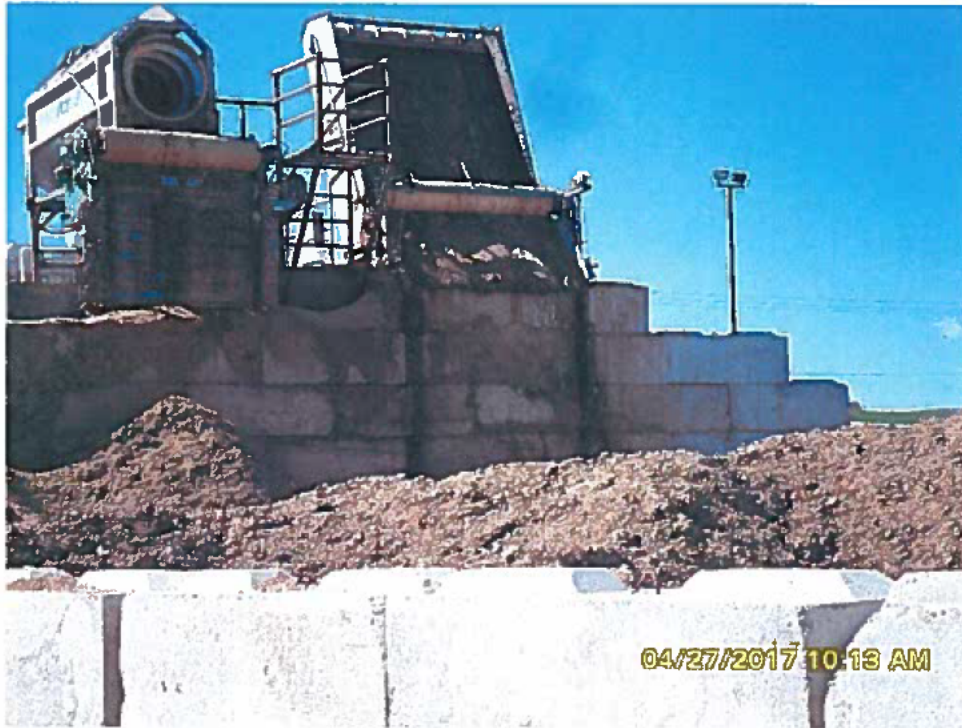
Photo #9: Southwesterly view showing the solids separator. Camera photograph #SAM 2788.

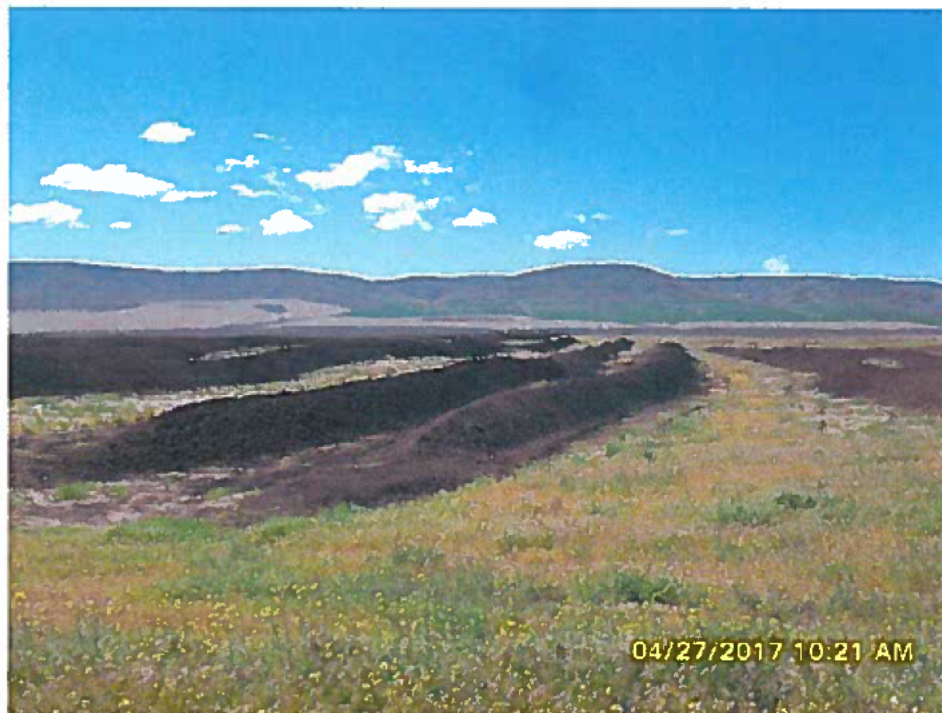
Photo #10: View of the manure composting area located approximately two miles west of the dairy. Camera photograph #SAM 2789.

Manure solids generated at the facility are either stored within the open lot confinement areas, or contained in the sedimentation basins. All solids at this facility are composted and then ultimately applied on farm ground owned by local farmers (via third party agreements) and utilized as fertilizer. The compost piles are located approximately two miles west of the dairy.
